Manhole Inspection Summary

Manhole # S45E2_048MH

Insp Date: **1/15/08 9:50 AM**

Location Address: **4123 Graham Ct**

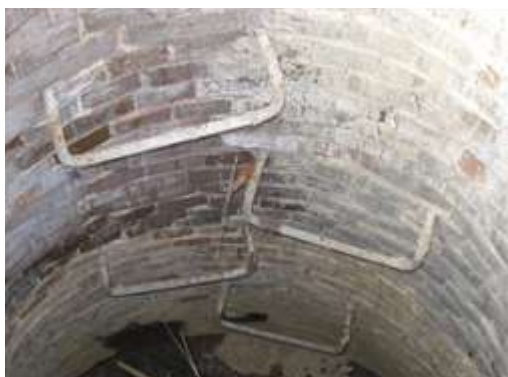
Steps Count: **4** Missing: **0** ☐ Corroded

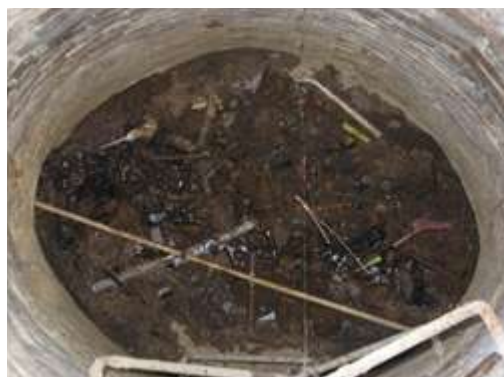
Defect 1

Debris

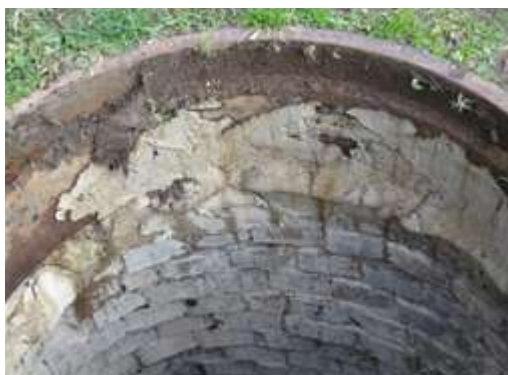
Defect 2

Infiltration: ☐ None ☐ Joint ☐ Cracks ☒ Mortar ☐ Roots ☐ Wall

Mortar

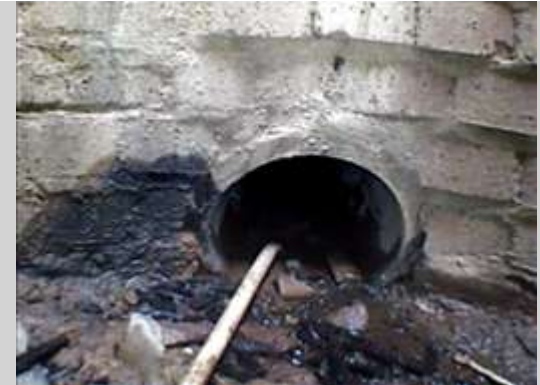
12 O'Clock Outflow

8 in. Circular Gravity Sewer
Pipe Out @ 12 O'Clock

Infiltration: **None** Pipe Seal Cond: **Sound**
